**ARBORICULTURAL APPRAISAL**

**HELL WATH  
RIPON  
NORTH YORKSHIRE**

**Prepared for  
The Friends of Hell Wath**

**22<sup>nd</sup> February 2024**

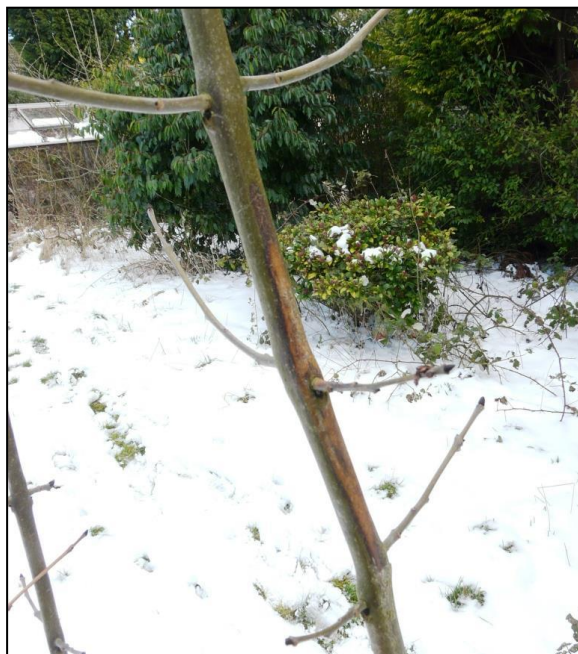
- 3.1.5 The initial symptoms are blackening and wilting of the leaves in the summer, which are then shed prematurely. The infection can then develop into the twigs and branches, often producing diamond-shaped lesions or cankers around the branch junctions as shown in the photograph below.

**Photograph 1: Example of a young self-set ash infected with Chalara dieback**

- 3.1.6** Given that this is a wind-borne disease, there is little that can be done to control its spread. Current experience is that young and coppiced ash trees can be killed quite quickly but older trees can live with the disease for some time until prolonged exposure, or another pest or pathogen, such as Honey fungus attacking them in their weakened state eventually causes them to succumb. Some infected trees are producing healthy new shoots from the base of the dead outer sections of infected twigs and branches, but it is unclear whether these will persist to develop a new, lower crown or if they will become infected and the dieback will continue.

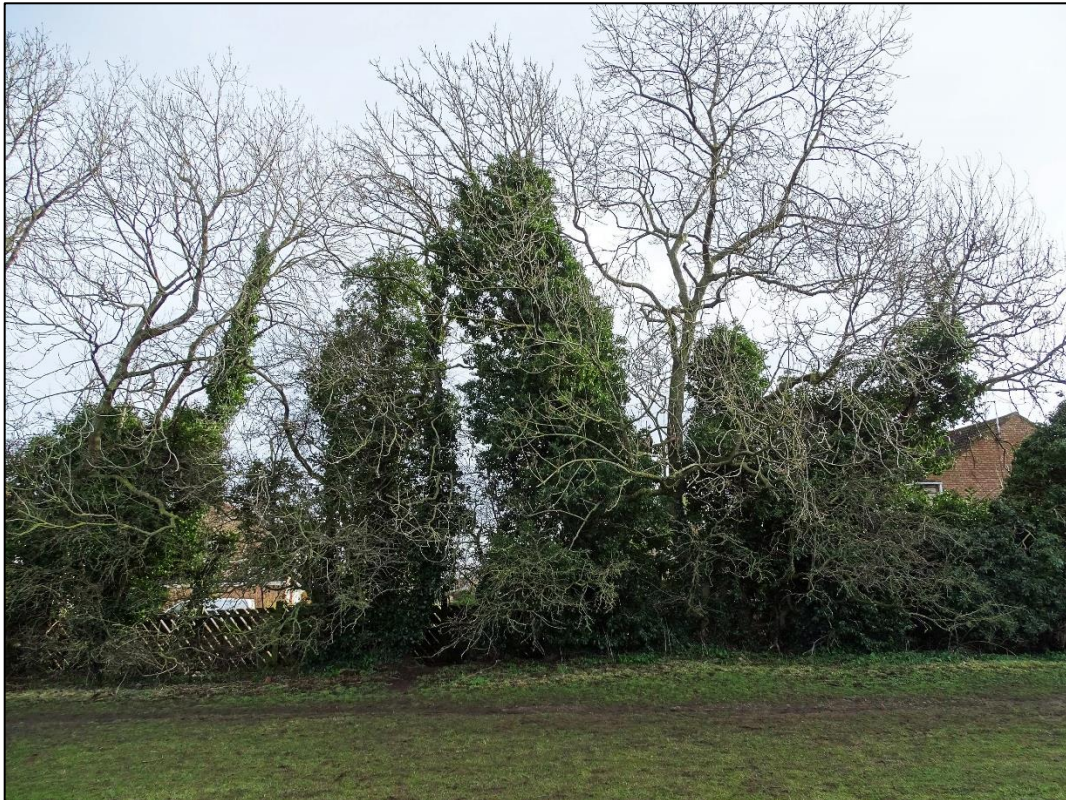
**3.2.1** Ivy is a significant issue affecting a number of the trees, particularly some of the ash and outgrown hawthorns in the hedgerow on the eastern side of the playing field 1b, and also further thorns in the northern boundary hedgerow. Ivy is not parasitic and a modest amount of growth on a tree is desirable, as it provides nesting opportunities for a variety of species of birds, some of which also eat its berries; its flowers are also a nectar source for various insects. However, once the ivy develops into a tree's crown it impedes growth and increases wind loading that can cause branch failure or uprooting in older, vulnerable trees.

**3.2.2** The most severely affected thorns are dying and/or becoming unstable as a consequence of becoming overrun with ivy. Several ash trees have become infested to the point that the branching in their lower crowns is being suppressed. A structured programme to manage the ivy on the most extensively affected specimens should be initiated, severing the dominant stems that are growing into the crowns whilst leaving the lower younger stems to maintain some cover. The severed stems should ultimately die and break up, falling to the ground. Where this could be a safety issue, the dead stems could be physically removed prior to them shedding. Whilst ivy can be severed at any time of the year, it should not be removed during the bird nesting season. Given the significant value of ivy to wildlife, control should only be considered where it is comprising the viability of important specimens or where there are overriding safety concerns. Overrun trees in areas with limited public access should be left to collapse naturally.

**Photograph 3: Heavily ivy-infested ash and hawthorn trees on the eastern edge of field 1b**

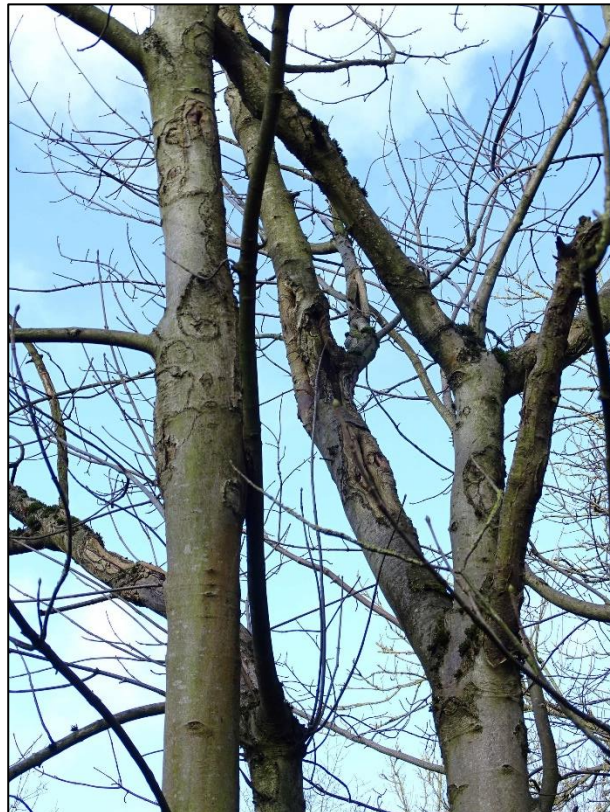
**3.3.1** There was evidence of bark stripping by squirrels on several sycamores but this generally appeared long-standing. However, if further succession planting is to be established, this will become vulnerable to irremediable damage by squirrels once it reaches pole-stage. Squirrel numbers should therefore be monitored and control measures taken to restrict them to an acceptable level as and when required. Links to Forest Research guidance are included below.

**Photograph 4: Old squirrel-related damage in the crown of a sycamore which has left the branches weakened and vulnerable to breakage**

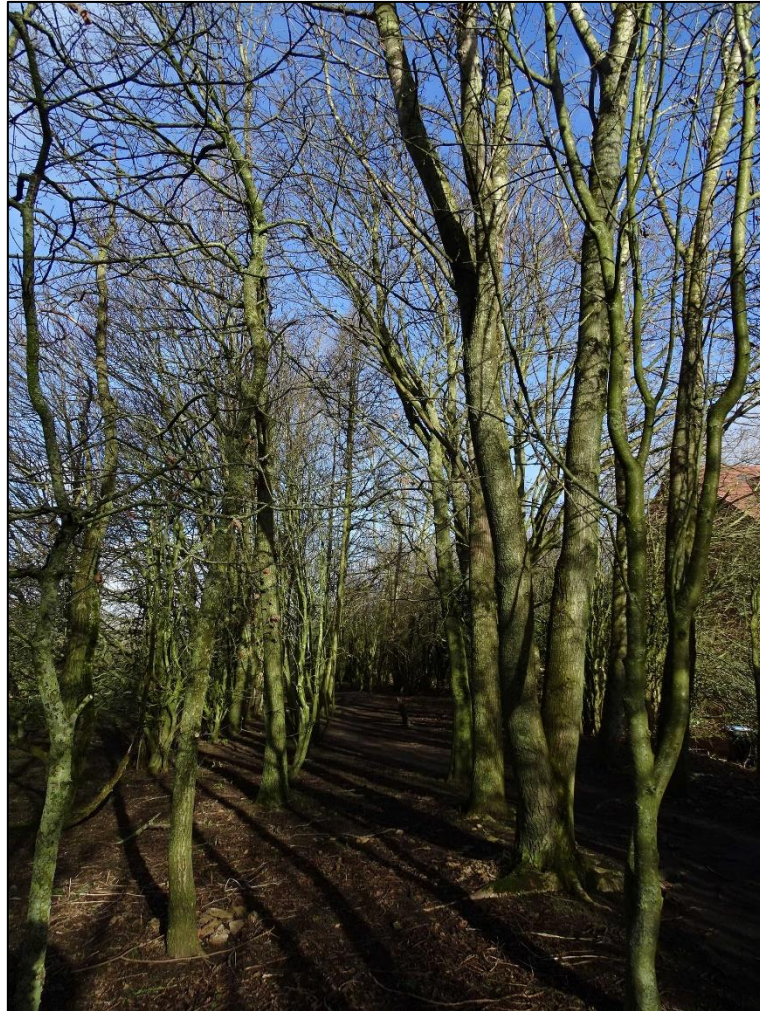
- 4.2** The shelterbelts have not been actively managed or selectively thinned as they developed and the dominant trees are generally tall and slender with restricted live crowns, whilst the less dominant species are suppressed. Several broadleaves are dead and many of the conifers are moribund; a number of the ash are infected with Chalara dieback. Due to the dense canopy there is no understorey and very little ground cover vegetation.

**Photograph 6: Looking north through the dense shelterbelt on the eastern boundary of area 5**

- 4.4** Both shelterbelts need to be selectively thinned, preferentially removing the dead, moribund, diseased trees and excessively slender trees, along with the poplars leaning excessively towards the adjacent properties or appear particularly vulnerable to failure. The long-term objective should be to open up and promote the development of the trees of the greatest long-term potential but this will need to be done gradually, over a number of years, to avoid suddenly excessively exposing the trees and leaving them vulnerable to windthrow. A number of the multi-stemmed trees, such as the field maples, could be topped to produce bushier specimens with dense low crowns. A proportion of the felled trees should be cut up and retained as dead wood habitat piles, provided there is limited risk of these being set fire to.

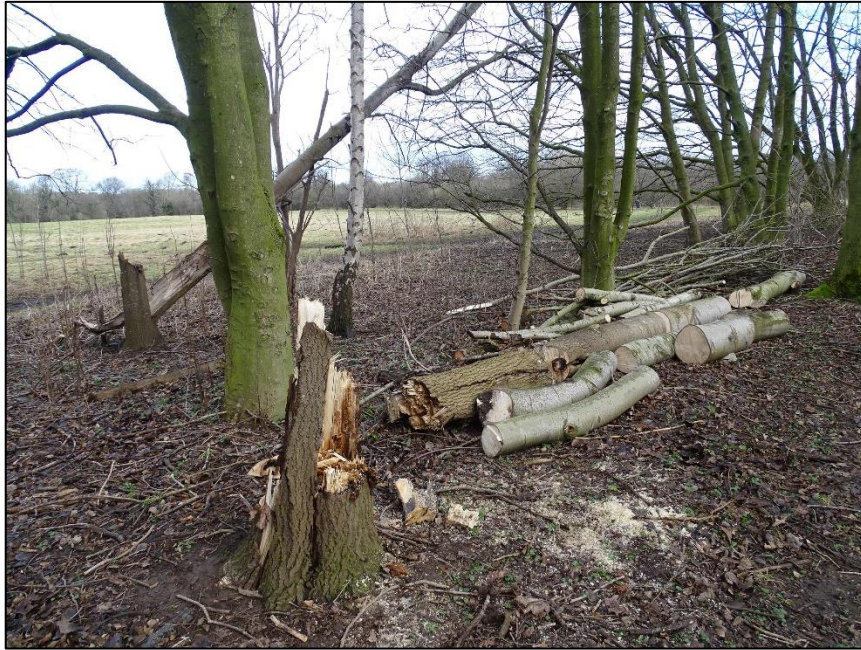
- 4.3** The hybrid poplars are particularly tall and several stems lean out towards the boundary of area 5 and the rear gardens of the adjacent properties on St Wilfrid's Close. Three of the grey poplar in the shelterbelt on the southern edge of area 8c have collapsed and others are vulnerable to failure.

**Photograph 7: Recently snapped decayed grey poplar in the shelterbelt on the southern edge of area 8c**

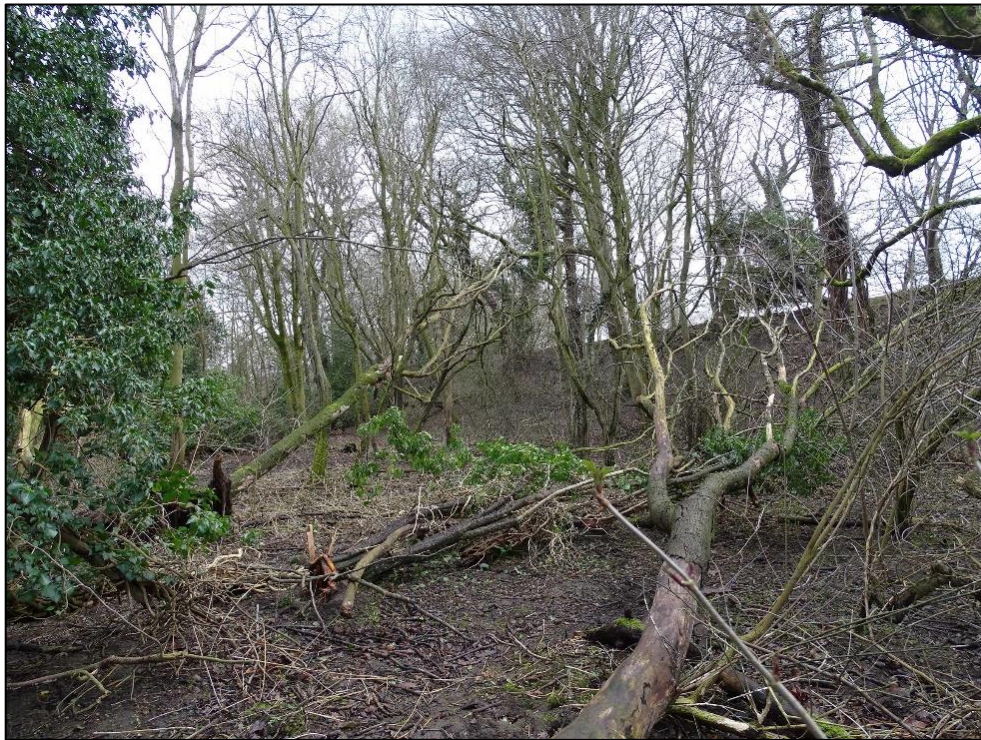
- 6.2** Within areas 7a and 9 there are groups of dead elms and diseased ash that could be cleared and expanded to produce clearings with sufficient light to successfully establish groups of canopy species trees with a shrub understorey around the periphery. A further suitable potential planting site was identified in area 3 adjacent to the river, where there is a large group of dead and dying elm, with some dying ash also present.

**Photograph 8: Potential site for clearance and planting in area 9**

- 6.3** The majority of the trunks and main limbs of the fallen and felled trees should be retained in piles adjacent to the planting areas when these are cleared as dead wood habitat. It would be advisable to enclose the planting areas with chestnut pale fencing to exclude people whilst the trees and shrubs establish, and all plants will need to be fitted with rabbit guards. Potential species for planting include oak, small leaved lime, wild cherry, field maple, silver birch, rowan, grey alder, goat willow, hawthorn, holly, yew and hazel; with the addition of crack willow and common alder adjacent to the river.

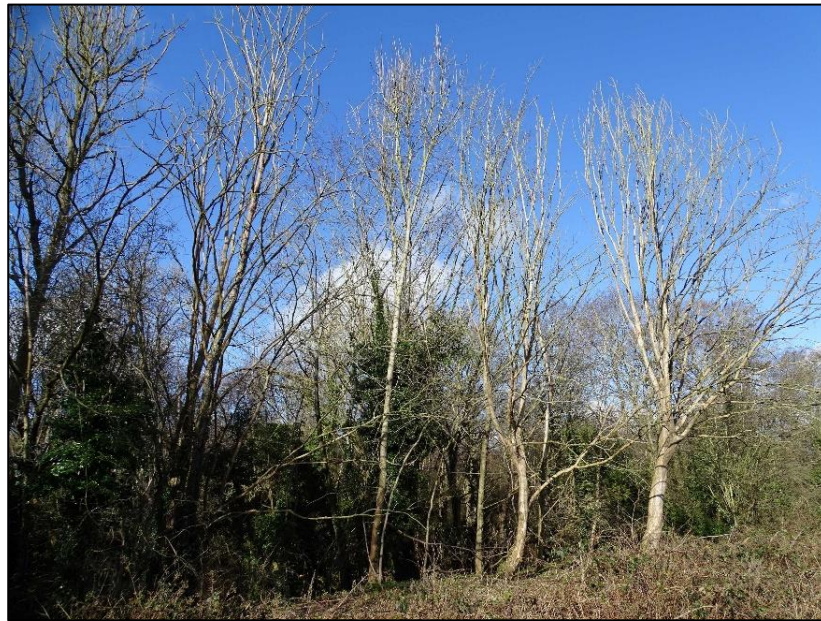
**Photograph 9: Potential site for clearance and planting adjacent to the river in area 3**

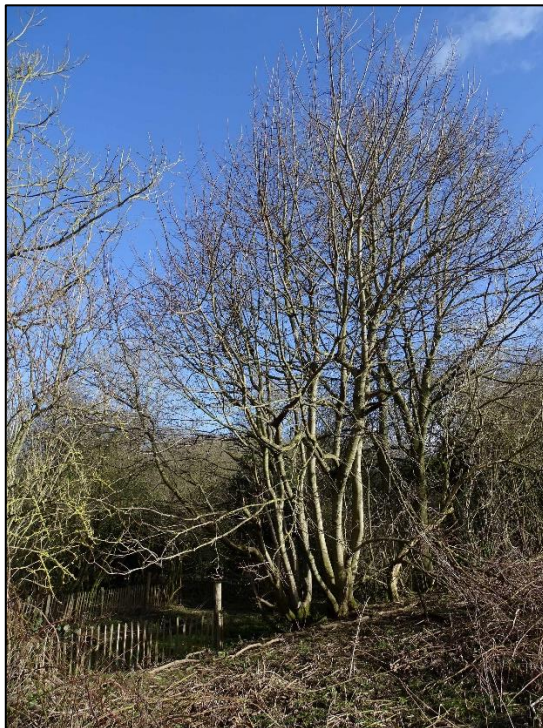
- 7.1** Two multi-stemmed sycamores on the southern bank are excessively shading the pond in area 7b and would be better removed. These are relatively poor quality trees, the loss of which would be outweighed by the beneficial impact on the pond.

**Photograph 10: Sycamores for potential removal adjacent to pond**

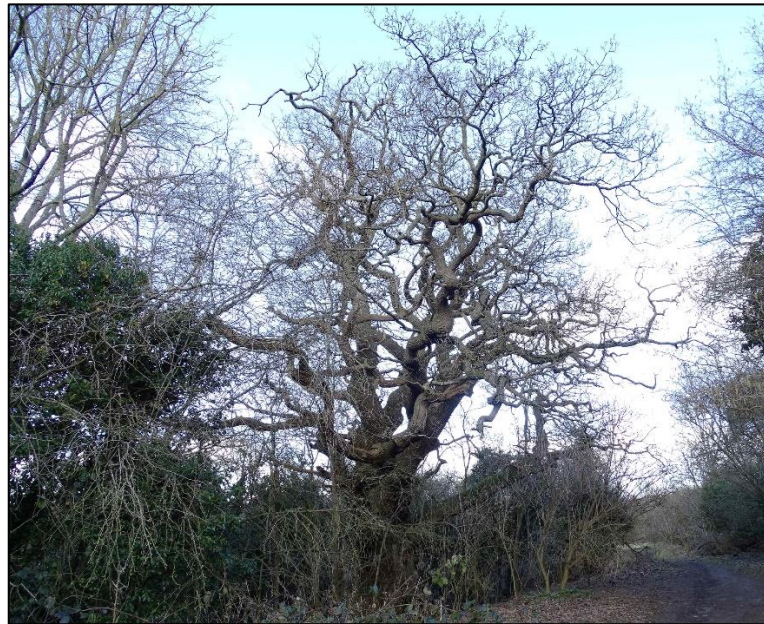
- 8.1 This is an especially fine, open-grown specimen with long-standing large diameter dead wood in the crown and basal fungal colonisation (Eiffel Tower Fungus - *Pseudoinonotus dryadeus*), making it particularly valuable from an ecological perspective.
- 8.2 There are elder bushes growing around the base on the eastern side and several slender hawthorns growing into the lower branches. This competing vegetation should be removed, along with the closest thorns on the western side. I did not identify any immediate remedial pruning requirements either on the oak or the veteran sycamore to the south.

Photograph 11: Veteran oak viewed from the south-east

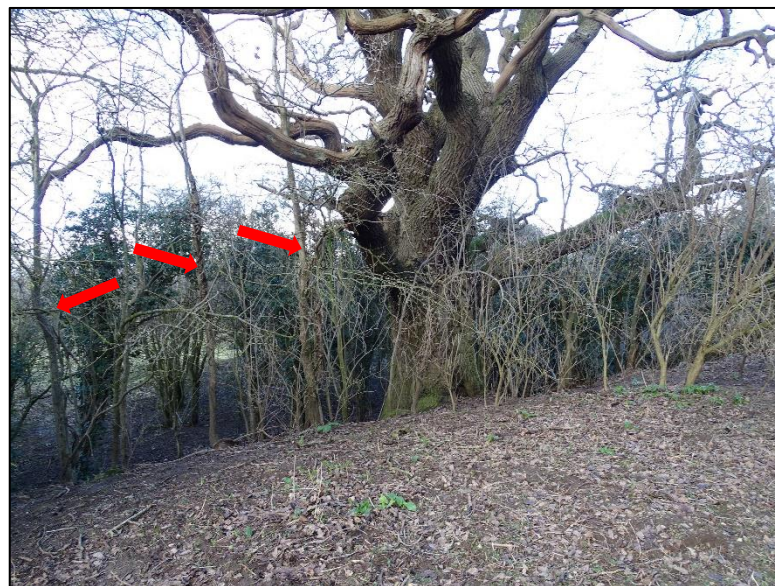
Photograph 12: Closer view of the competing vegetation around the veteran oak with the hawthorns growing into the lower southern bracing arrowed
