**ARBORICULTURAL APPRAISAL**

**HELL WATH  
RIPON  
NORTH YORKSHIRE**

**Prepared for  
The Friends of Hell Wath**

**22<sup>nd</sup> February 2024**

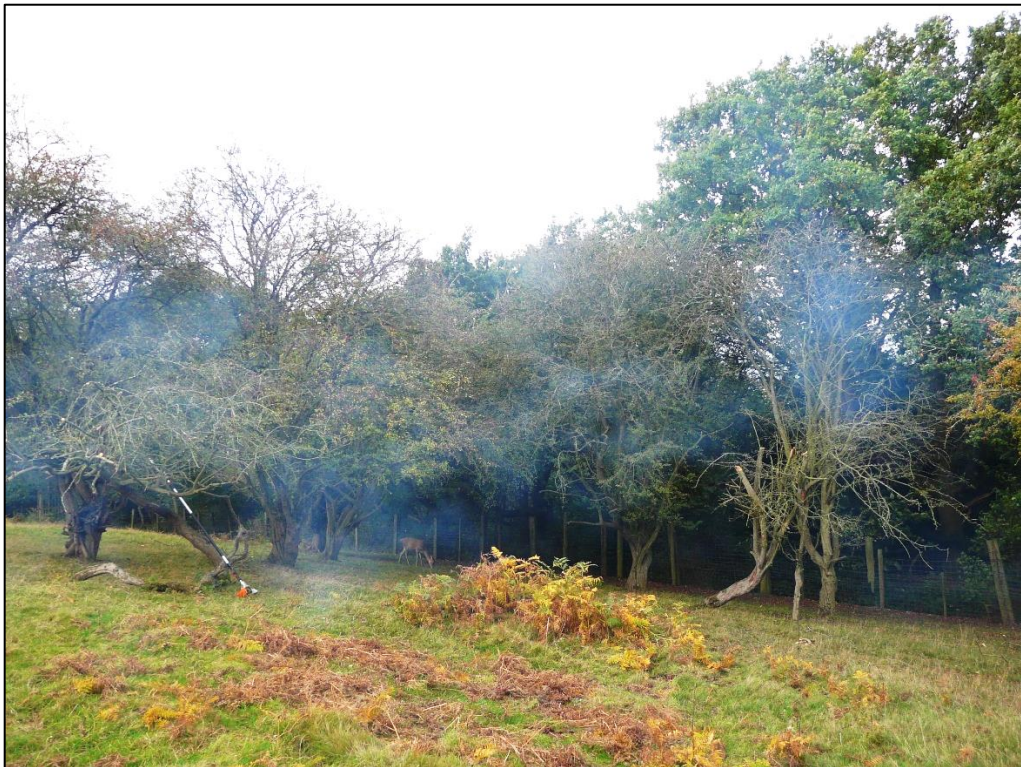
- 3.4.2** Where areas of hawthorn have been thinned out, a number of the retained trees are slender, with restricted high crowns. A proportion of these could be topped to initiate the production of new shoots at a lower level, promoting the development of dense, more compact crowns over time. As the response to such heavy pruning is unpredictable and can be affected by periods of drought in the summer after cutting, this treatment should be used selectively, where the loss of an occasional specimen will not be critical. Trees which already have some young live shoots are most likely to respond favourably.
- 3.4.3** There is a group of old hawthorns to the west of the Fairy Steps which are top heavy and beginning to collapse. Consideration should be given to the selective topping of those that are most susceptible to failure.

**Photograph 5: Example of old hawthorns being topped in a deer park to maintain their stability and promote new growth at a lower level but above browse height**
